Bonded Metal-Free Bridge

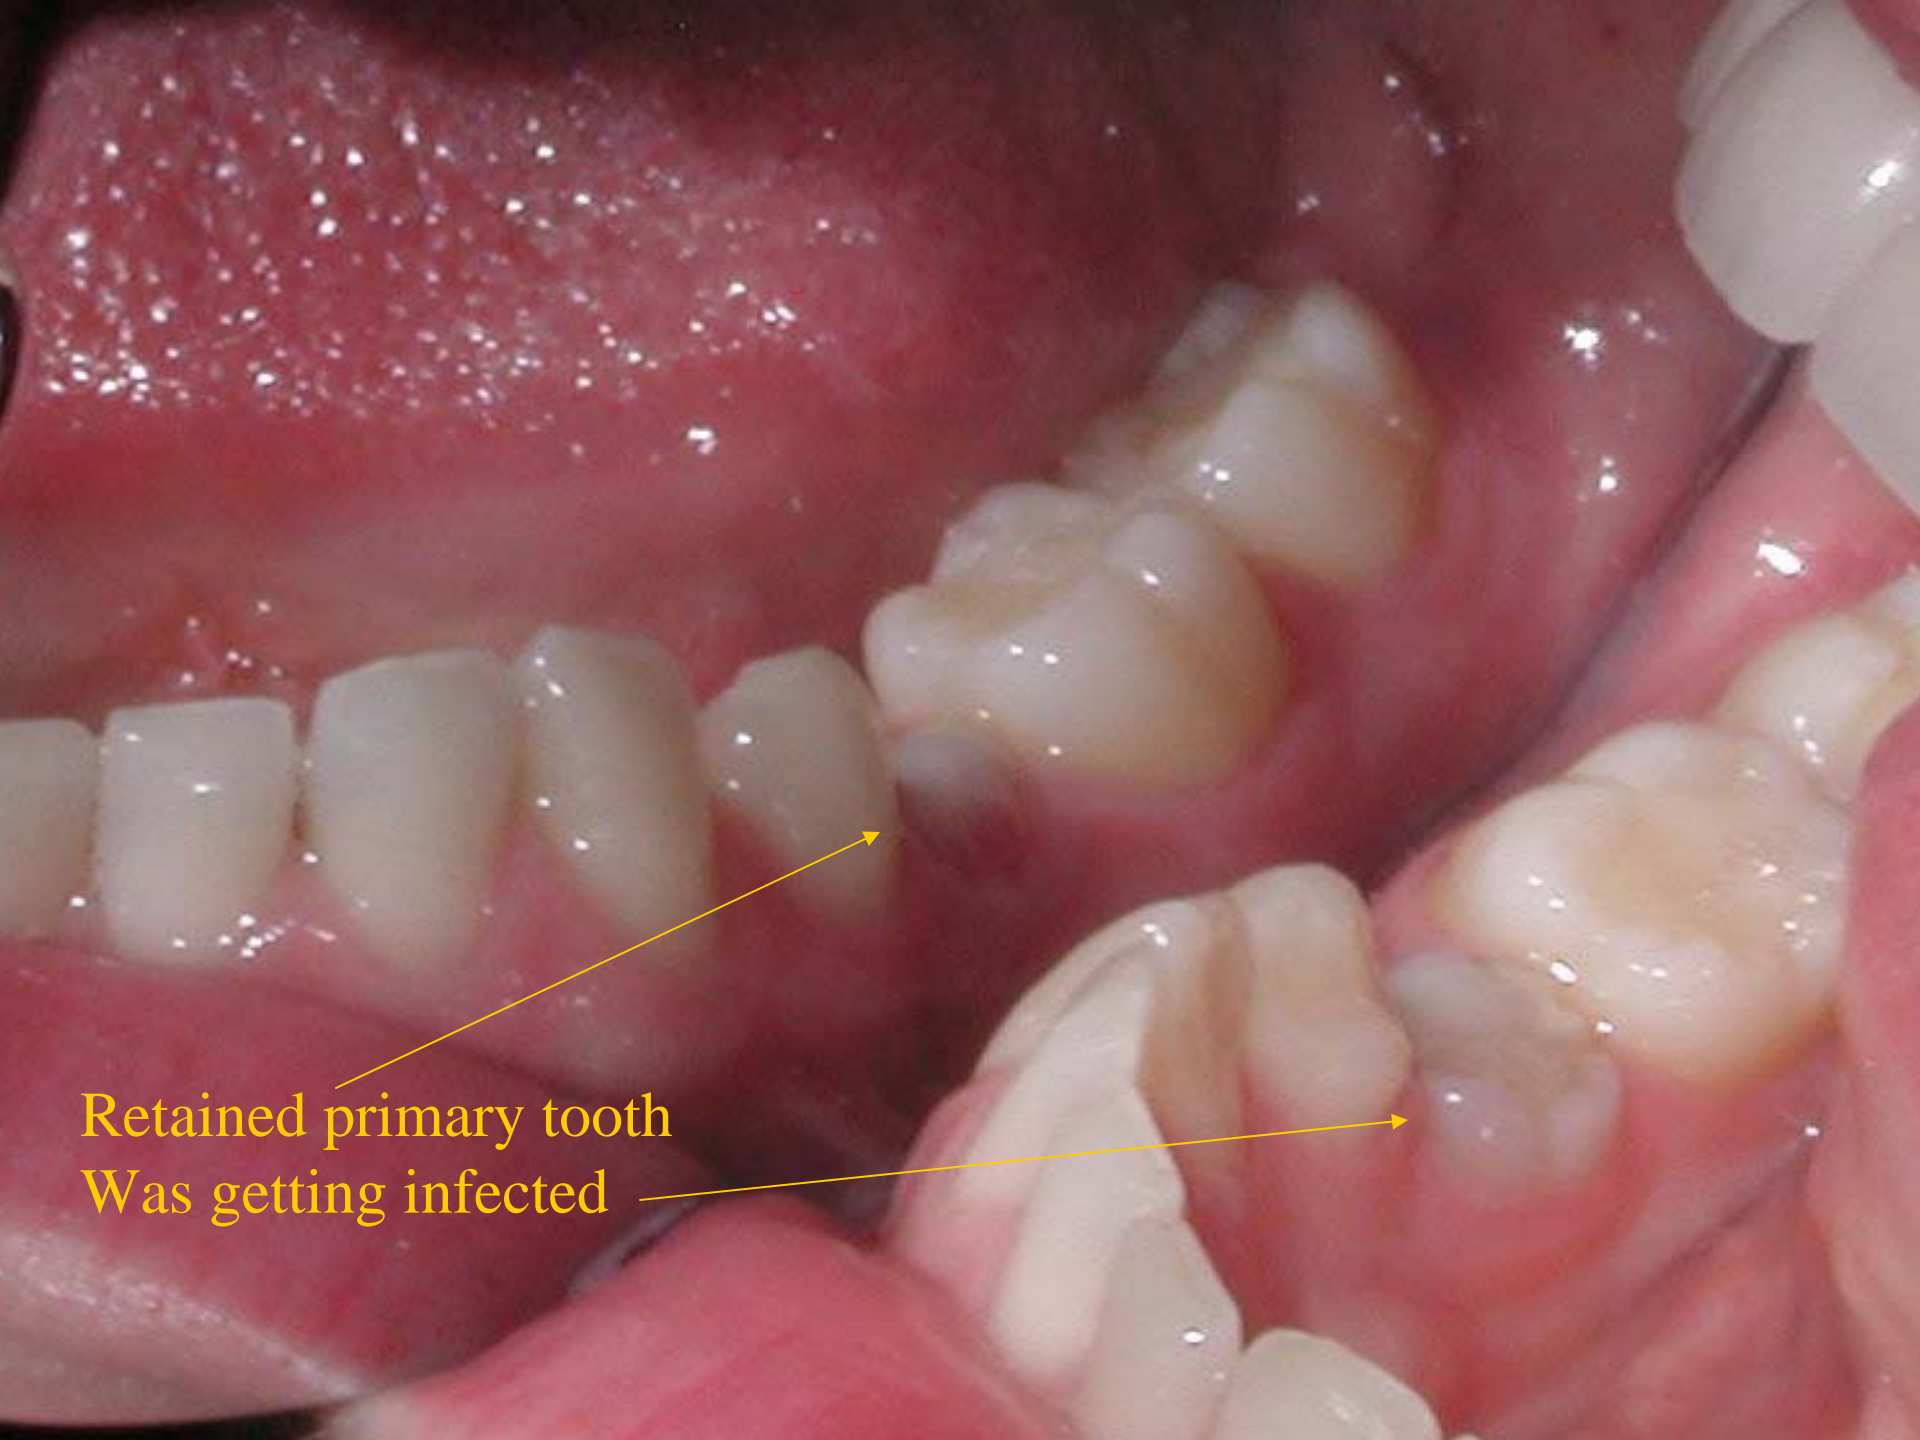
Retained primary tooth
Was getting infected

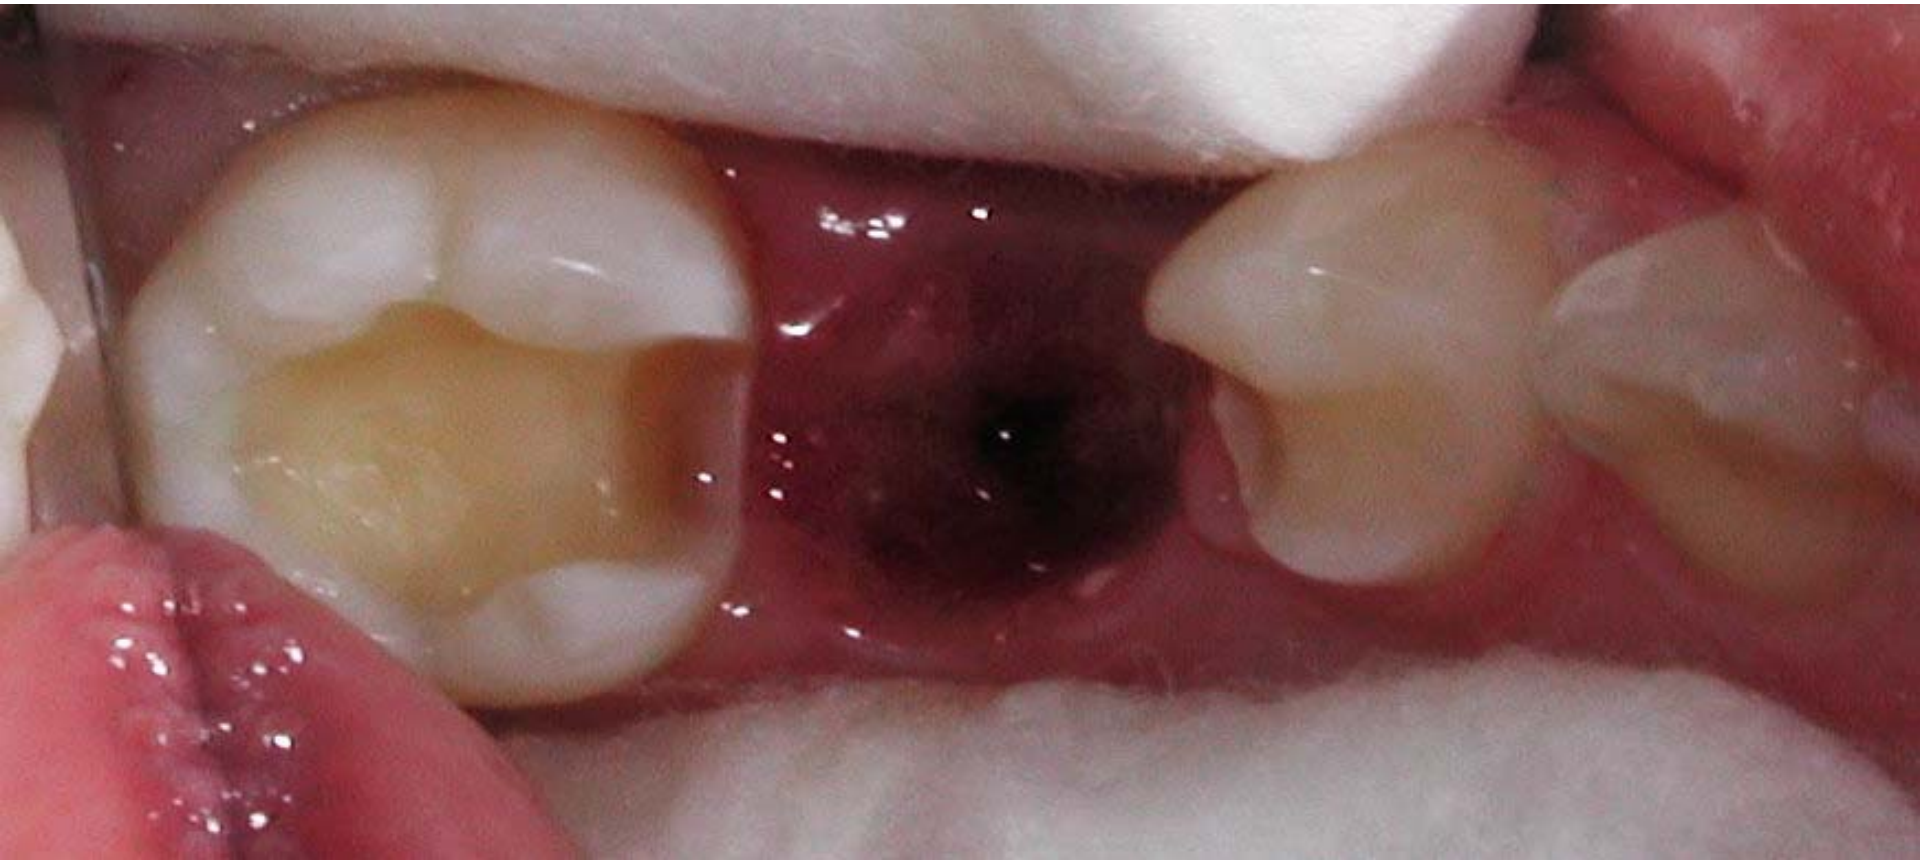
A retained primary molar was removed due to infection

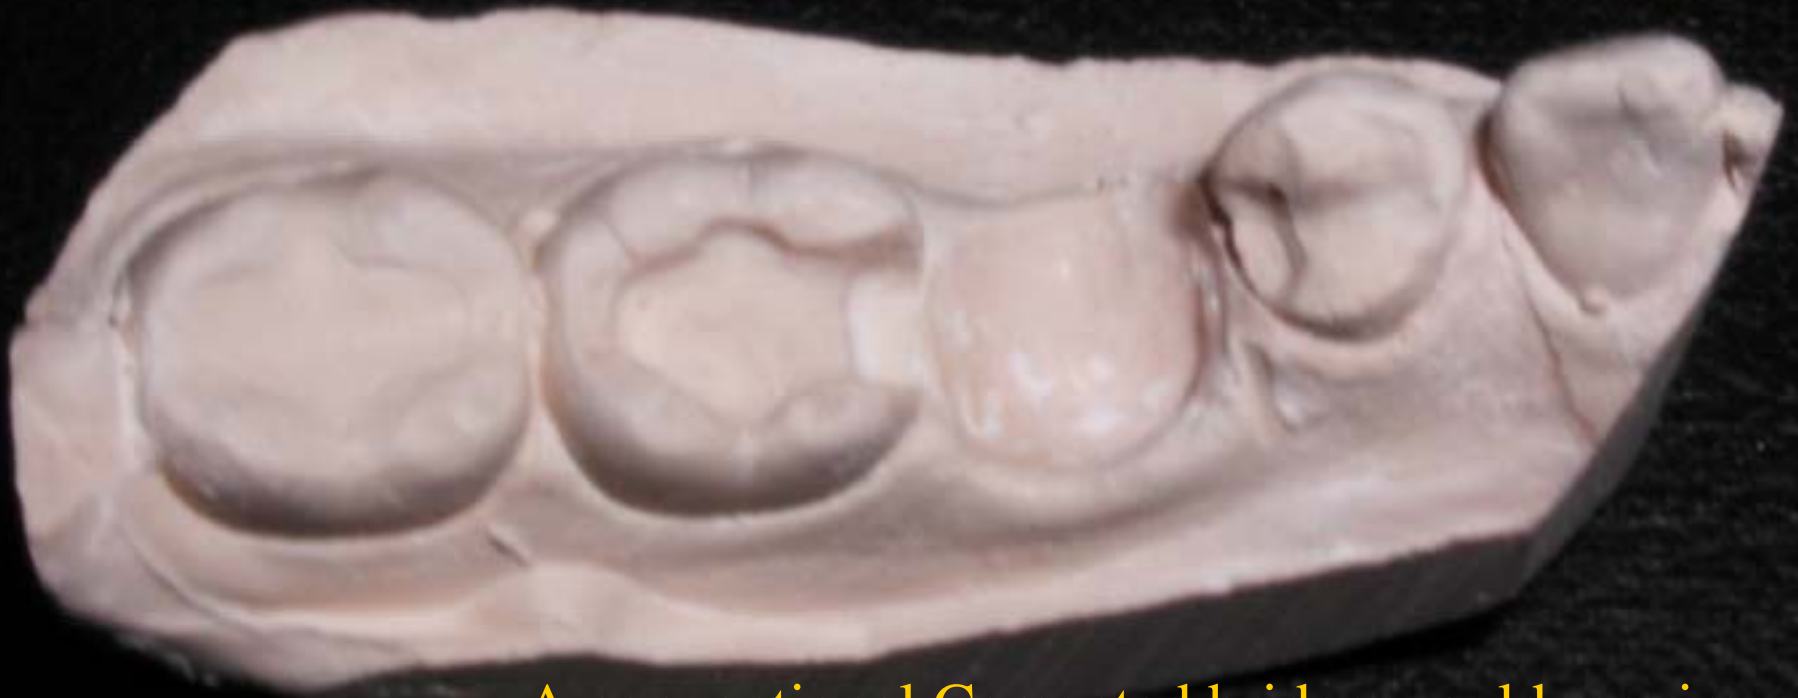
A conventional Cemented bridge would require
removal of ALL Of the enamel of teeth on
either side of the space.

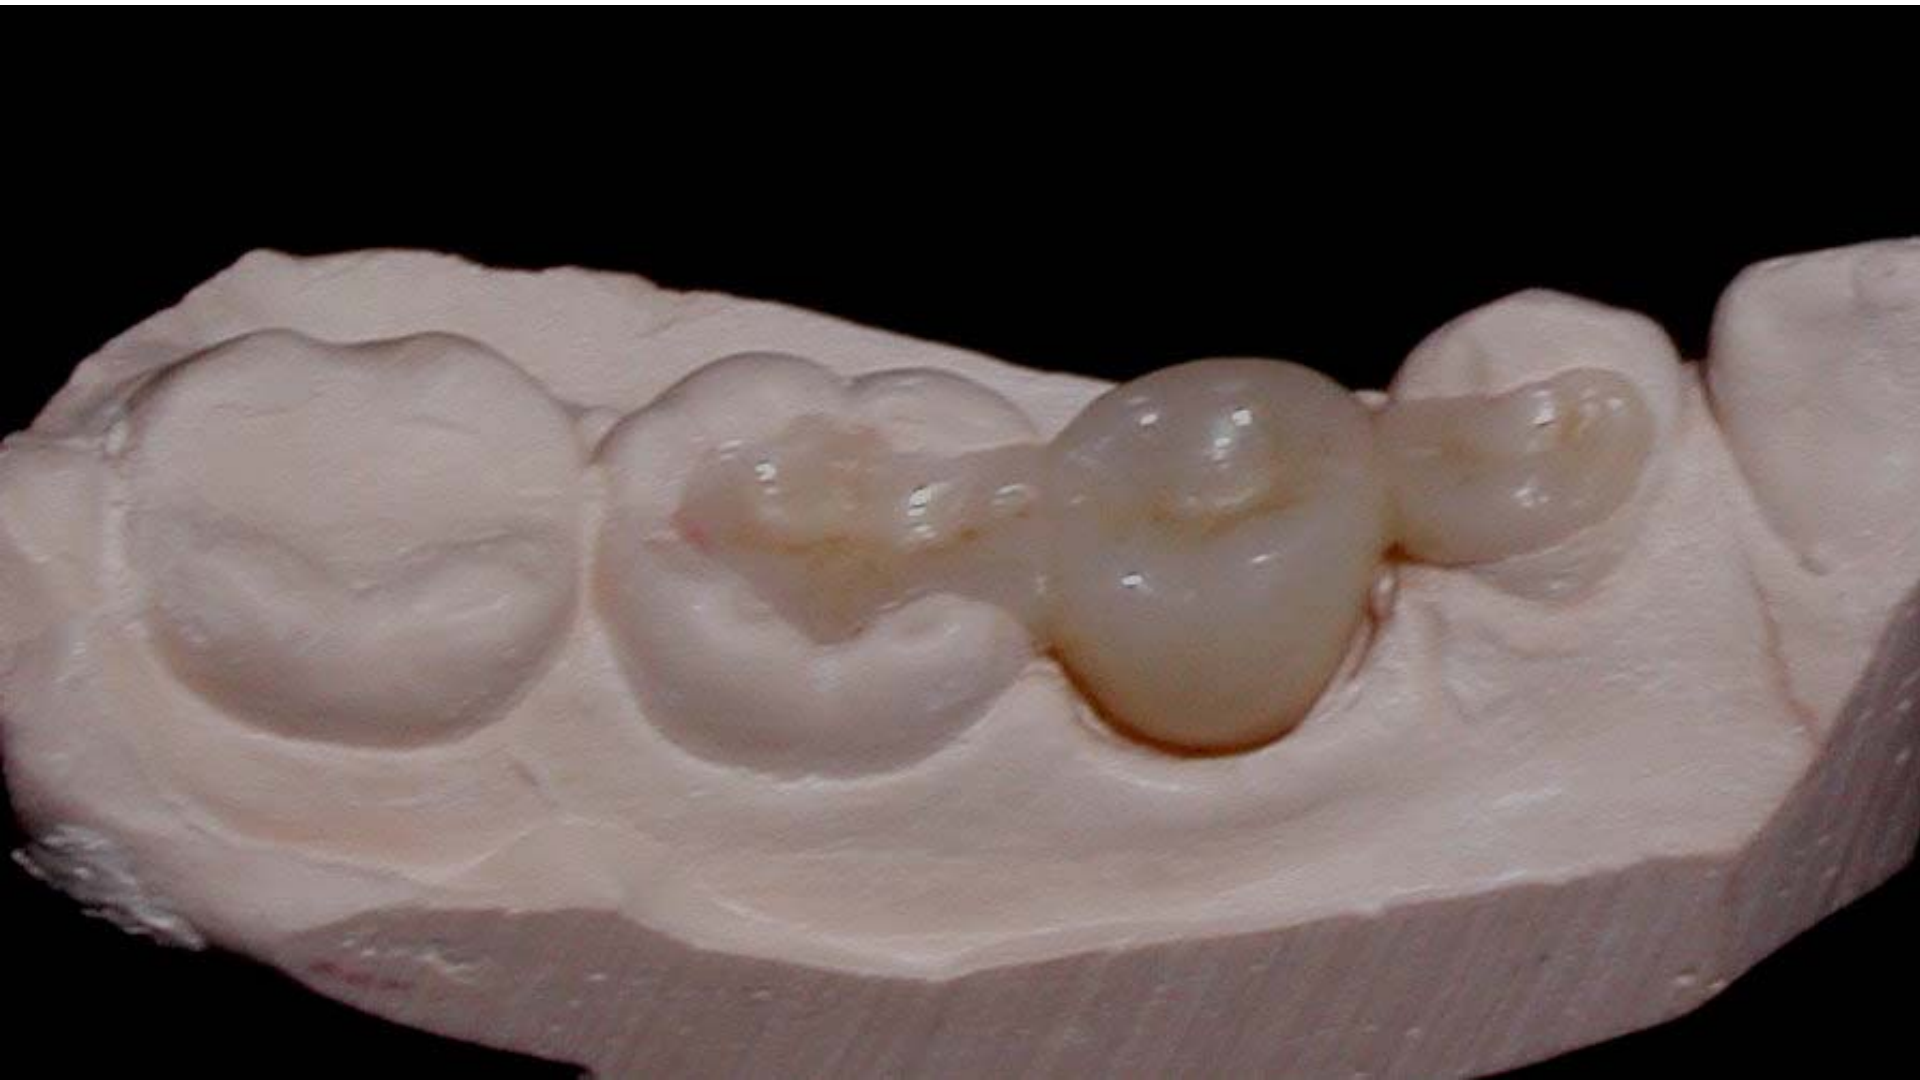
Metal-free bridge on the model

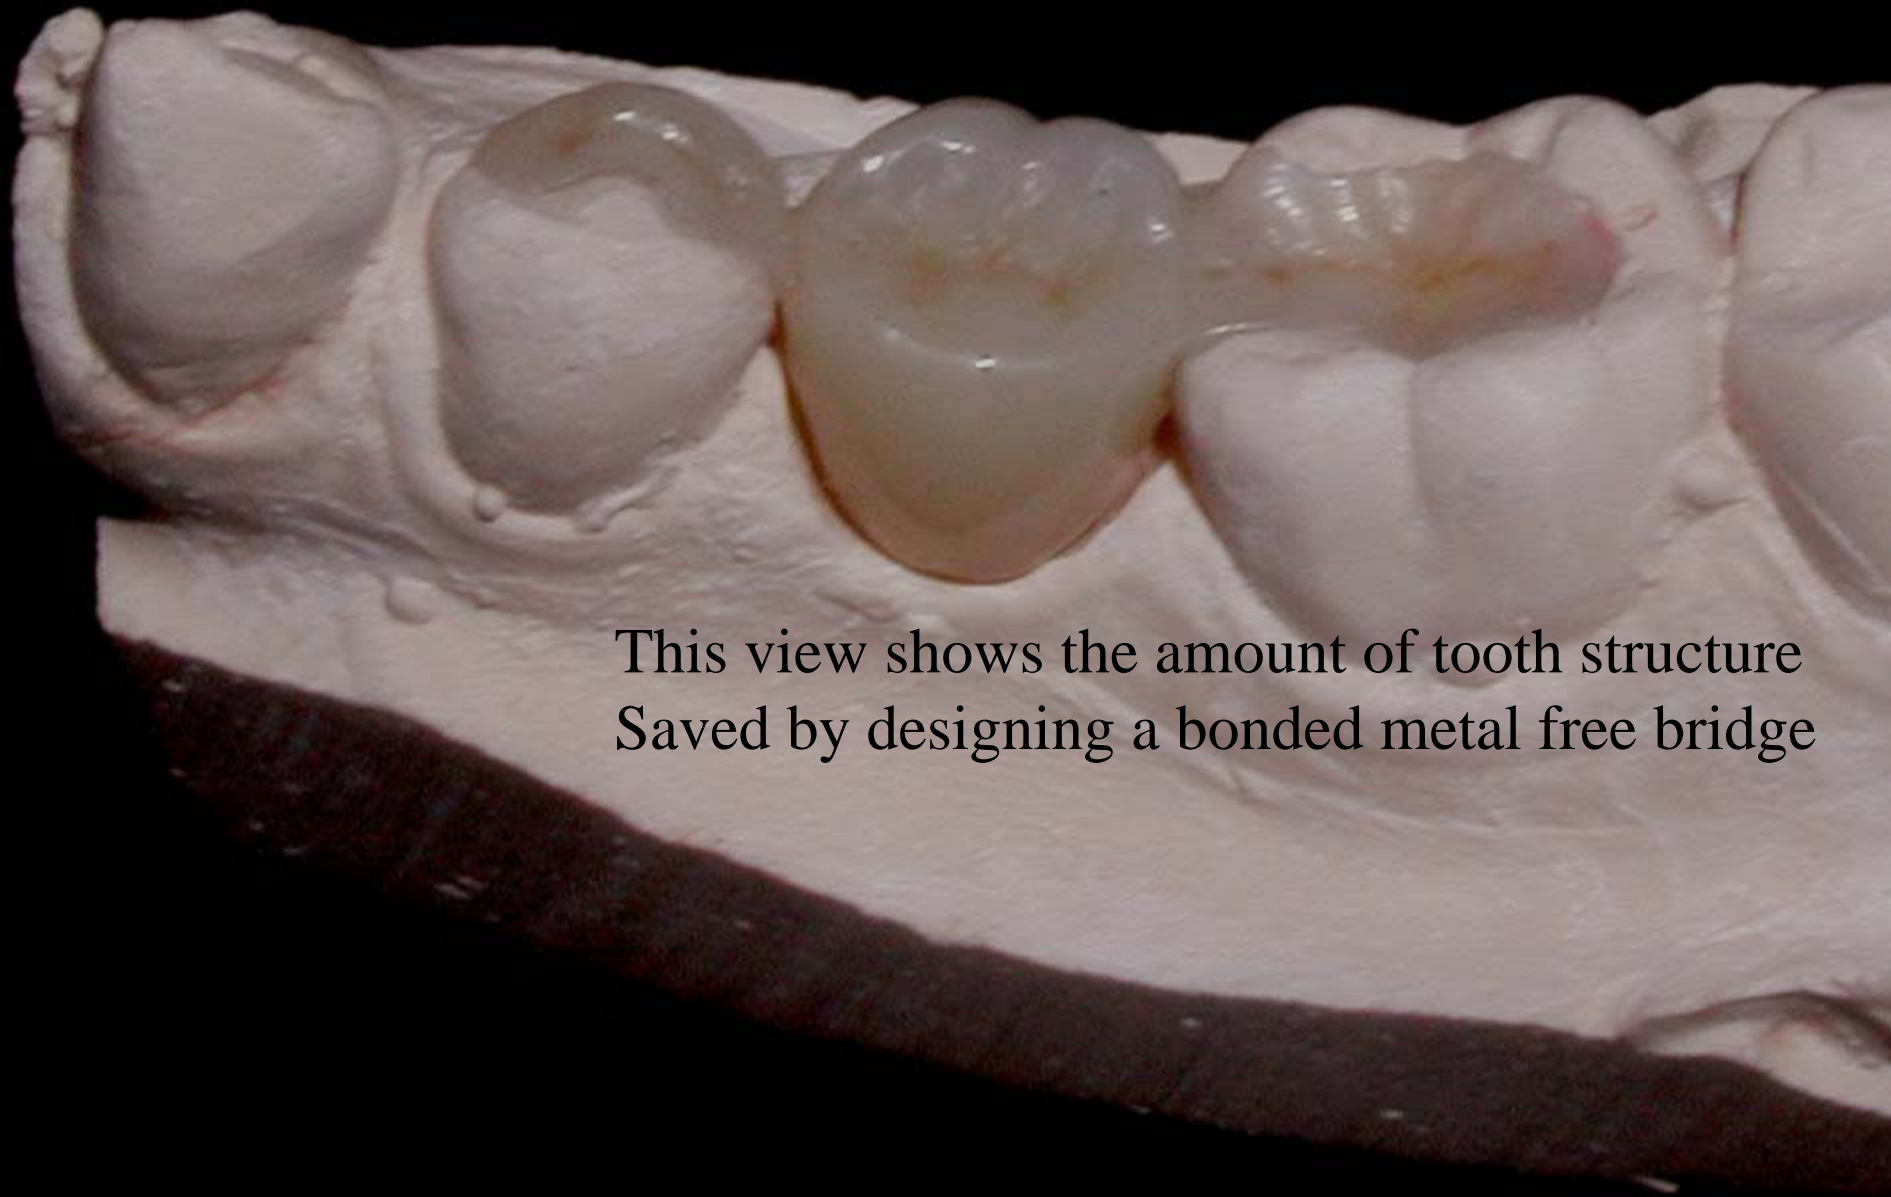
This view shows the amount of tooth structure
Saved by designing a bonded metal free bridge

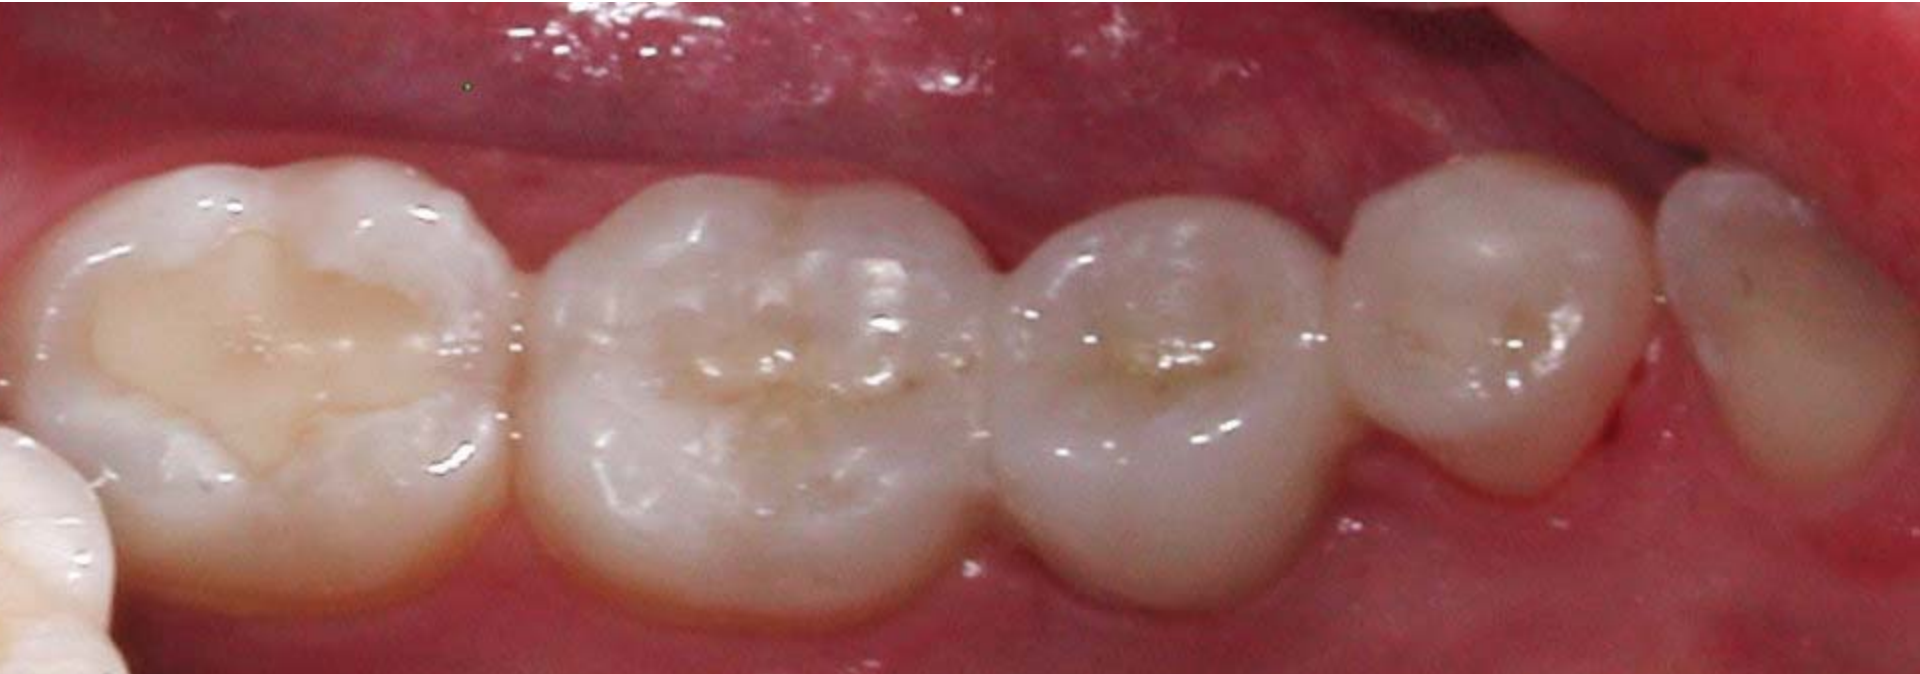
Bonded metal free bridge in the mouth

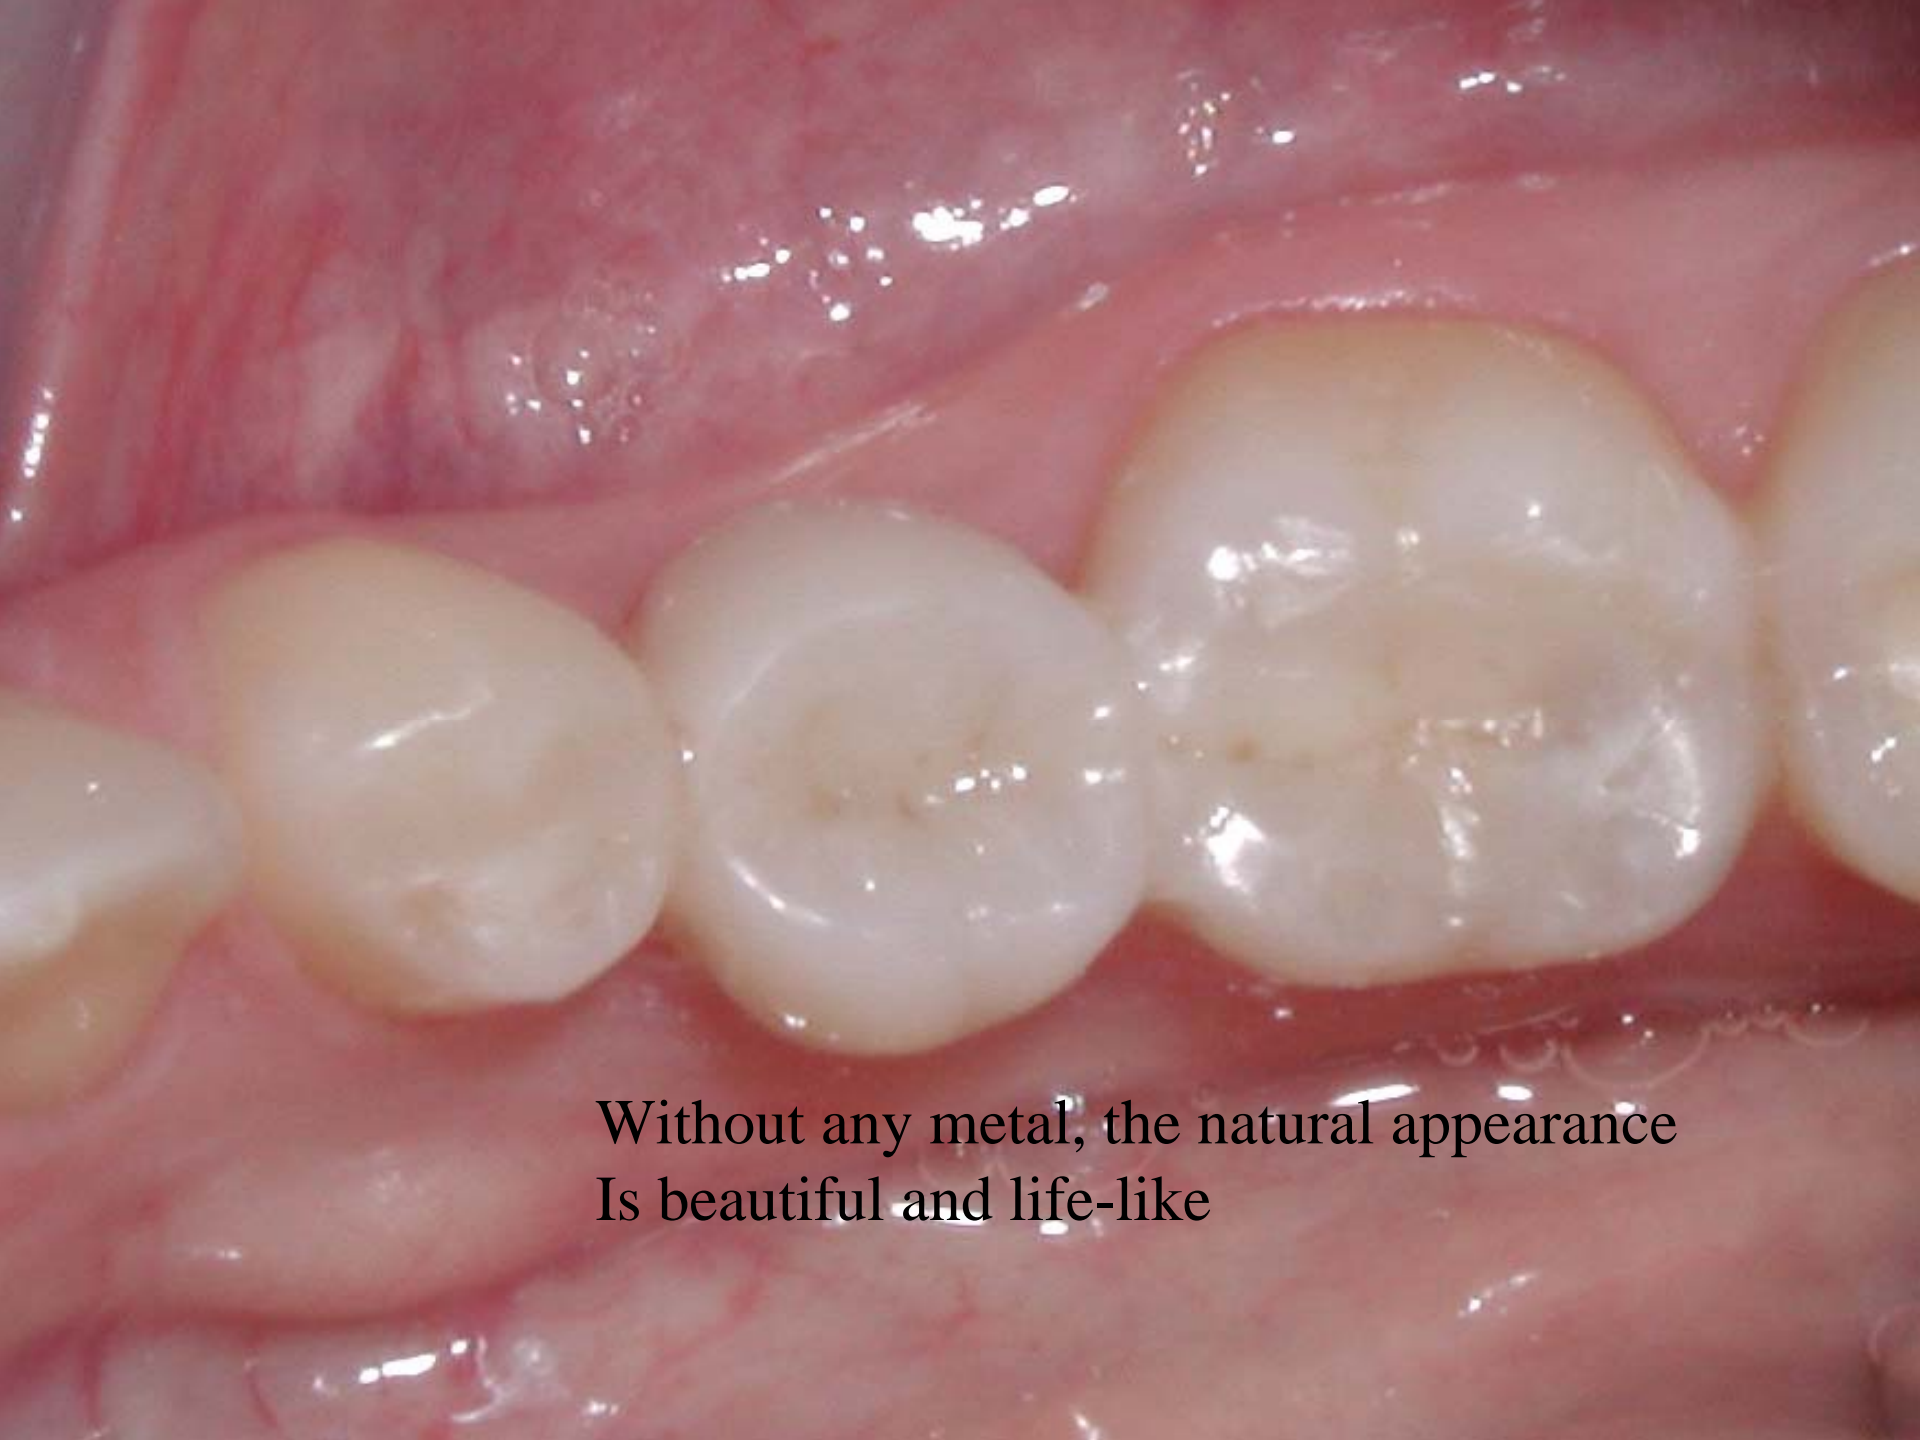
Without any metal, the natural appearance
Is beautiful and life-like
